**Harmful Algal Bloom Report ID 2027 – Willow Lake (Plumas County) Lassen National Forest**

**July 29, 2019 – Willow Lake (Plumas County) – Caution advisory recommended**

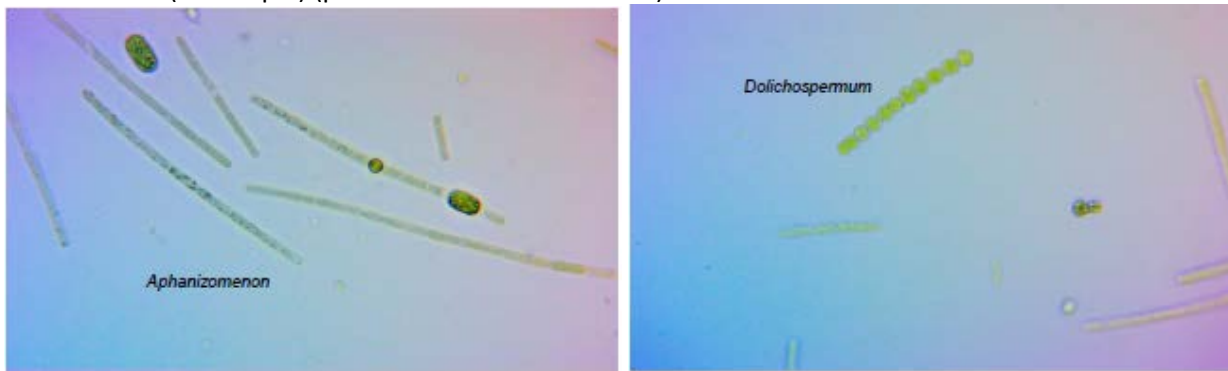
Site ID 43930 (1<sup>st</sup> sample) (photo credit: Bend Genetics)

Sample name	Cyanobacteria Identified
43930 (1 <sup>st</sup> sample) (40.40474, -121.35839)	High amount of Aphanizomenon spp. and a low amount of Dolichospermum spp.
43926 (2 <sup>nd</sup> sample) (40.40276, -121.35735)	High amount of Aphanizomenon spp. and a low amount of Dolichospermum spp.

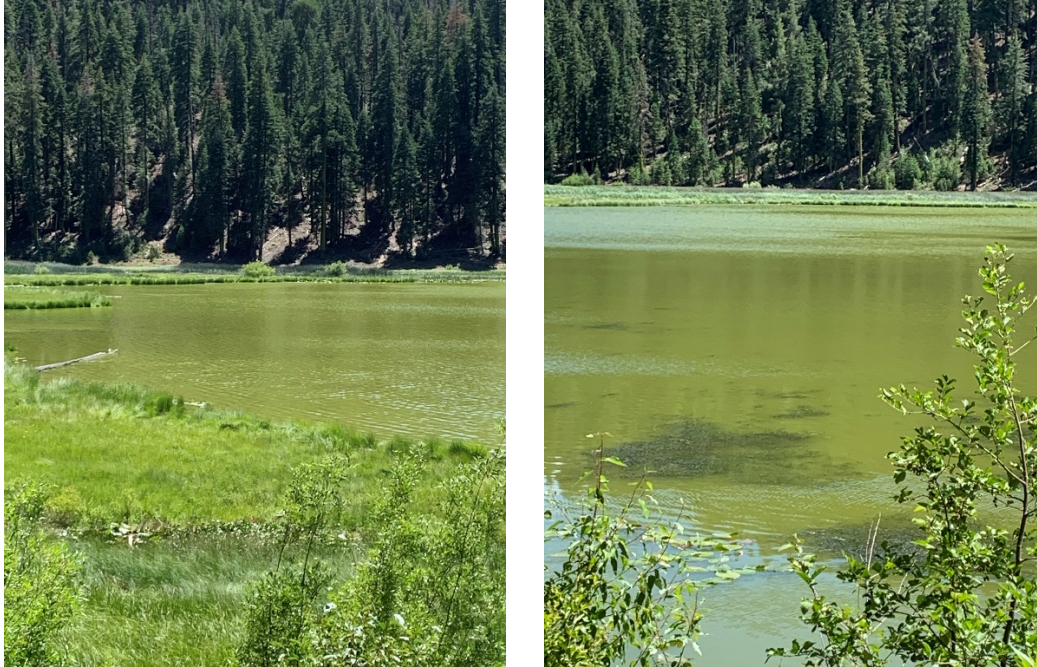
On July 15, 2019 US Forest Service staff visited Willow Lake based on a public complaint concerning water conditions. During the staff visit, staff noted that the water appearance looked like pea soup. Water samples were collected for performing the jar test. The jar test was positive, so site photos and results of the jar test were sent to the Water Boards for assessment along with a request for assistance in analysis.

**Figure 2. Site photos of Willow Lake taken on July 15, 2019 (Photo Credit: Craig Hemping, USFS)**

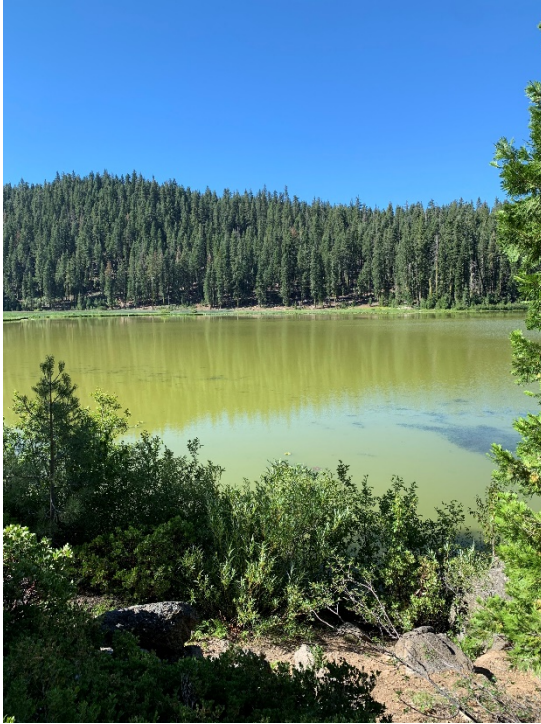
On July 22, 2019, US Forest Service staff revisited Willow Lake to check on site conditions and, if needed, collect additional water samples for lab analysis. According to forest service staff, the watercolor appeared to be a slightly different color as compared to the previous week. Color appeared more brown than green. However, site conditions still looked to be impaired.

**Figure 3. Site photo of Willow Lake taken on July 22, 2019 (Photo Credit: Craig Hemping, USFS)**

Ultimately, the advisory signs, if any, posted at the water body will need to be decided by the US Forest Service in consultation with the Plumas County Environmental and Public Health offices. At a minimum, all recreational users should be encouraged to practice [healthy habits](#) when recreating in waters known to experience HABs.
