# Lake Britton 2016 Water Quality Monitoring

September 2016

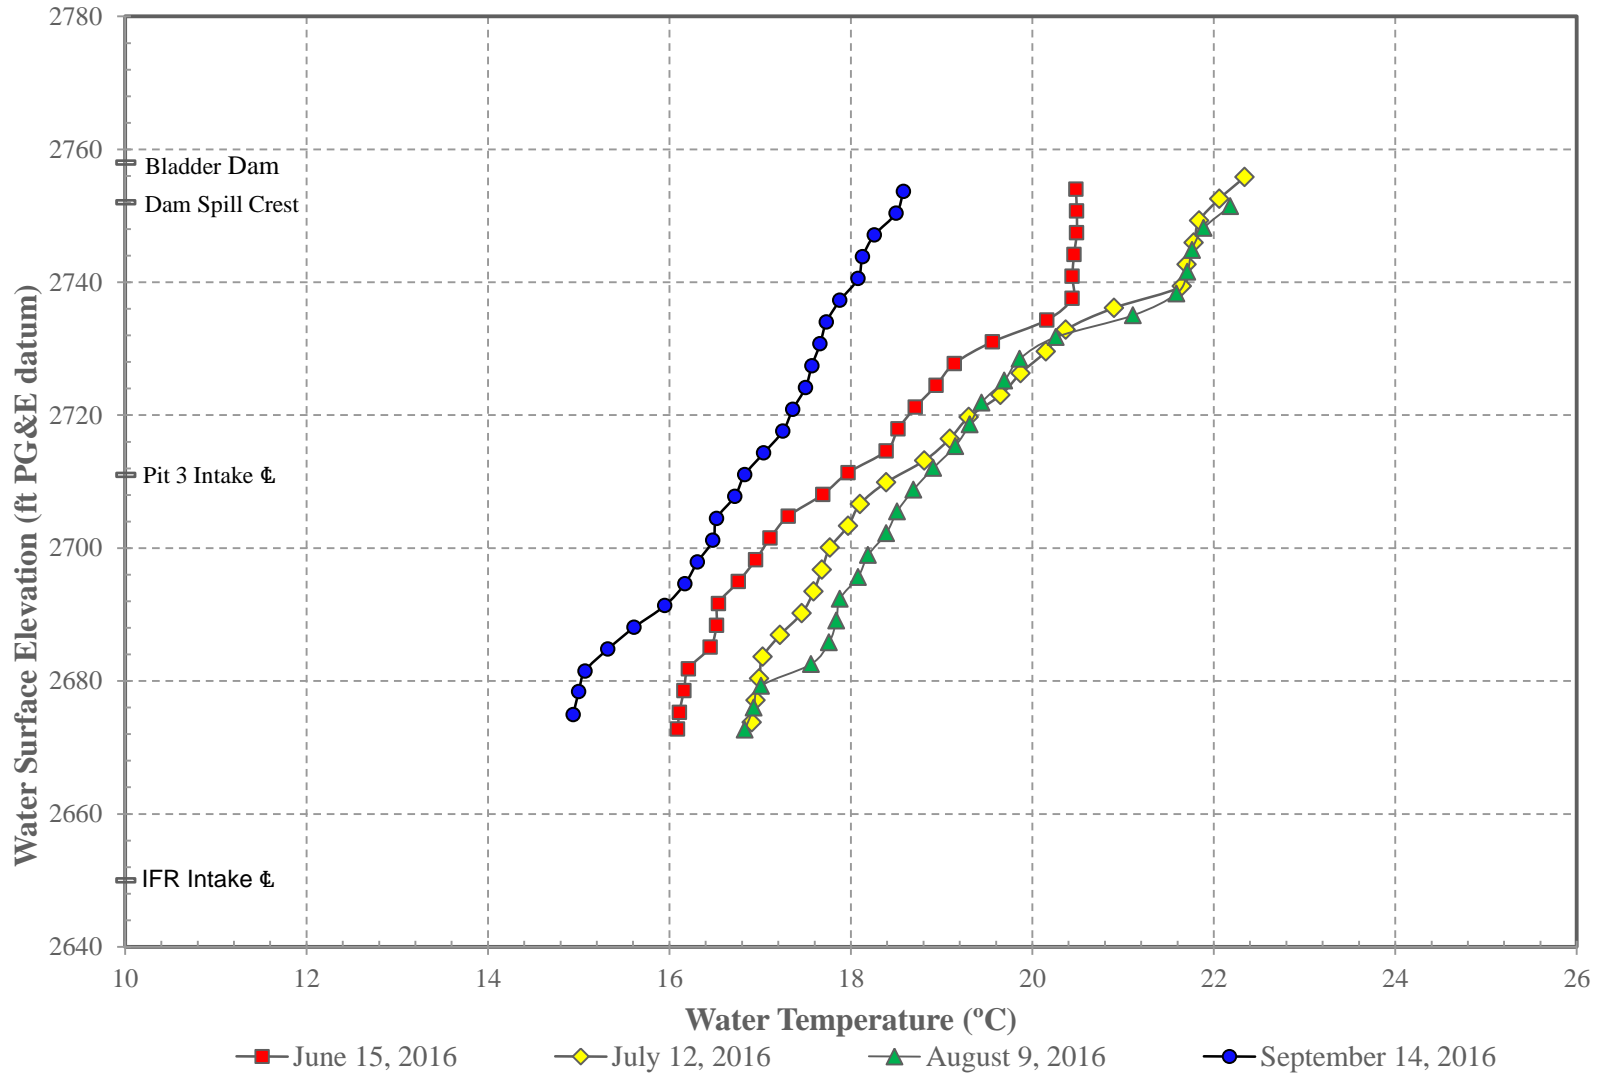
# Lake Britton Water Temperature Profiles

- Characterize the effects of the new license flow regime on summer water quality (DO and water temperature) in Lake Britton.
  - Monthly synoptic water quality monitored in Lake Britton (1 profile station near dam).
    - June 15<sup>th</sup>, July 12<sup>th</sup>, August 9<sup>th</sup>, September 14<sup>th</sup>
  - Install seasonal meteorology station at Pit 3 Intake.
- Perform visual assessment for the presence/absence of algal blooms in Lake Britton.
  - Conduct monthly visual assessments and photo documentation.

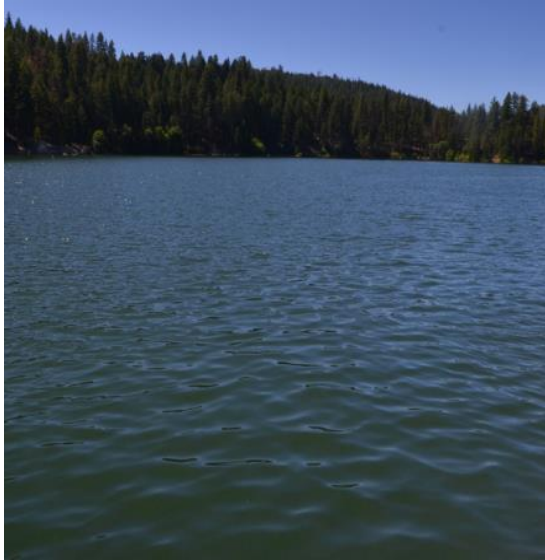
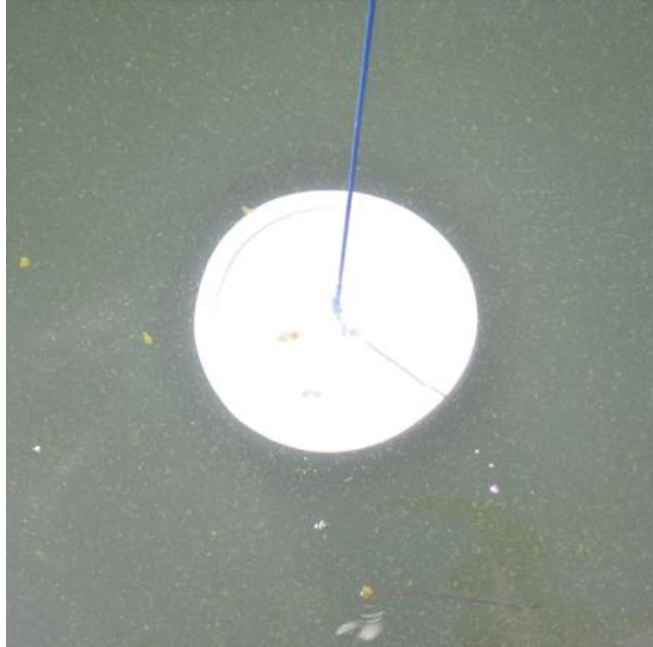
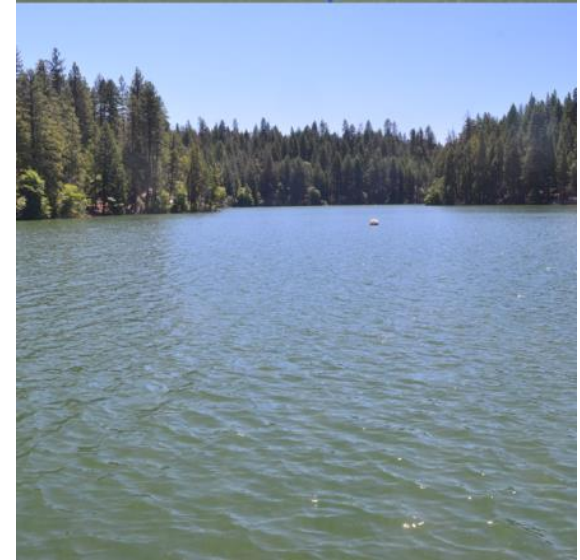
# State Park—Marina Dock (July 14, 2016)

- Moderate cyanobacteria concentration in July 2016.
  - Some accumulation in quiet cover areas (e.g., State Park Marina, Jamo Boat Ramp).
- Abundance low in August, no film/scum.
- Factors possibly influencing algae production:
  - Water year with moderate inflow (reduced residence time).
  - Cooler meteorology.
  - Moderate turbidity during spring run-off (limited light penetration to sediments).

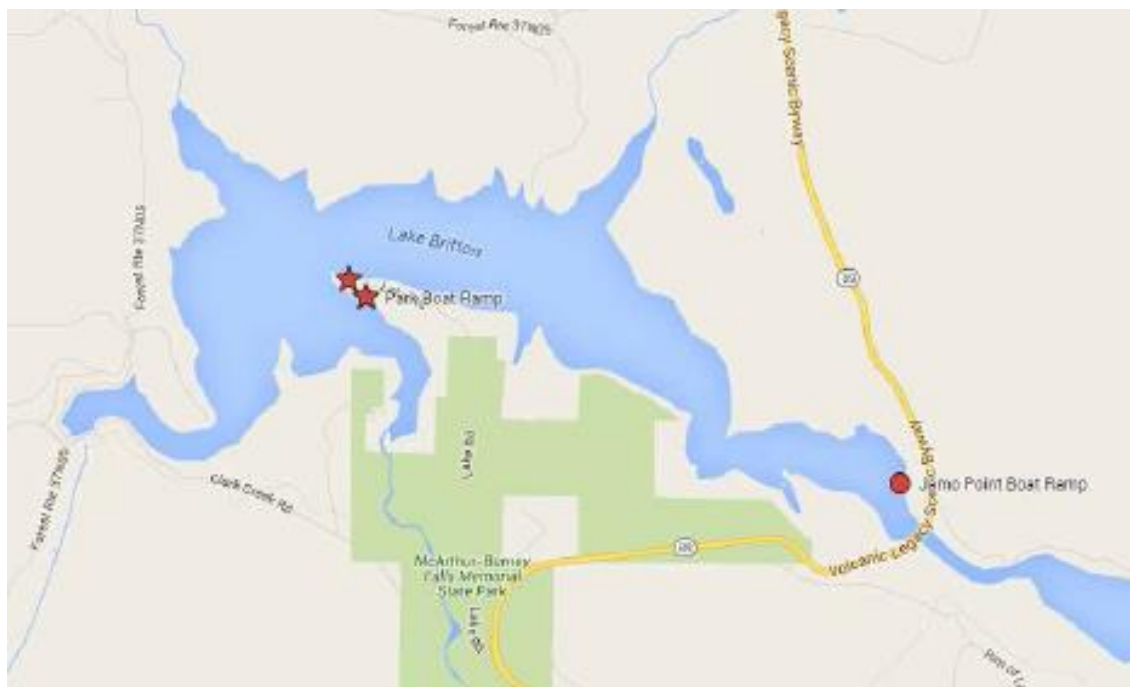
July 18, 2016 — Lake Britton water samples from State Park Swim Beach and Burney Creek Cove Marina Boat Ramp  
Visual observations at Jamo Point Boat Ramp (no sample taken)

Cyanobacteria genera ID'd Gloeotrichia, Aphanizomenon, and Anabaena
